Investigation of the Cylinder Liner Wear in Agricultural Tractors

Khodabakhshian Kargar, R., & Baghbani, R. (2023). Investigation of the Cylinder Liner Wear in Agricultural Tractors. *Journal of Agricultural Machinery*, 13(1), 15-25. <https://doi.org/10.22067/jam.2022.72790.1066>

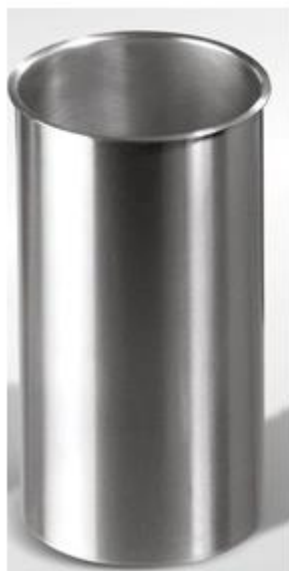
Fig. 1. A sample of the cylinder liner

Keyhan Sanat Ghaem Company, as one of the largest manufacturers of cylinder liners in Iran and the Middle East, was selected as the case study. The current research was conducted in 2021 in this company. Given the purpose of the study, 25 cylinder liners of the Perkins 4-248 engine, which was related to the Massey Ferguson 285 tractor were selected (Fig. 1).

The tested cylinder liner material is made of high-quality cast iron (GG 25) with a diameter of about 101 mm. Table 1 presents the chemical analysis and mechanical

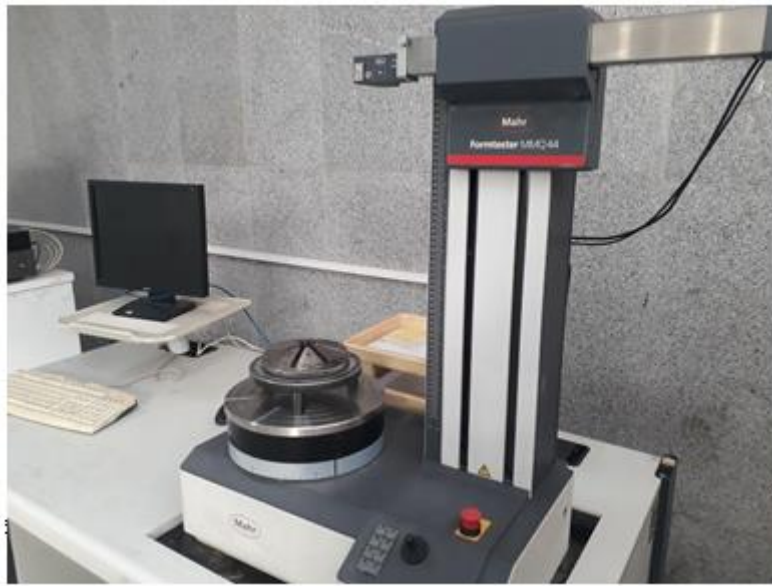
Fig. 2. The Formtester used for measuring dimensional and geometric specifications of cylinder liner

The dimensional and geometric specifications of the studied cylinder liner were measured and evaluated using the Formtester MMQ 44, Mahr Company, Germany equipped with the LSQ computational algorithm in the metrology laboratory of the Keyhan Sanat Ghaem Company (Fig. 2). The Formtester device applied in this work was, in fact, a special cylinder liner, which was able to produce correct and principle results with consistent repeatability in the geometric deviations of the

liner's inner surface. The approximate transfer speed of the Formtester was 20 mm s^{-1} and the approximate scanning speed of the test device rod during the evaluation period was 20 mm s^{-1} . The evaluations on the roundness and concentricity of the cylinder liner were conducted in 12 circular positions with the same lengthwise distances (Fig. 3). Additionally, the straightness was measured in 5 lines with the same lengthwise distances in 90° around the cylinder liner environment.

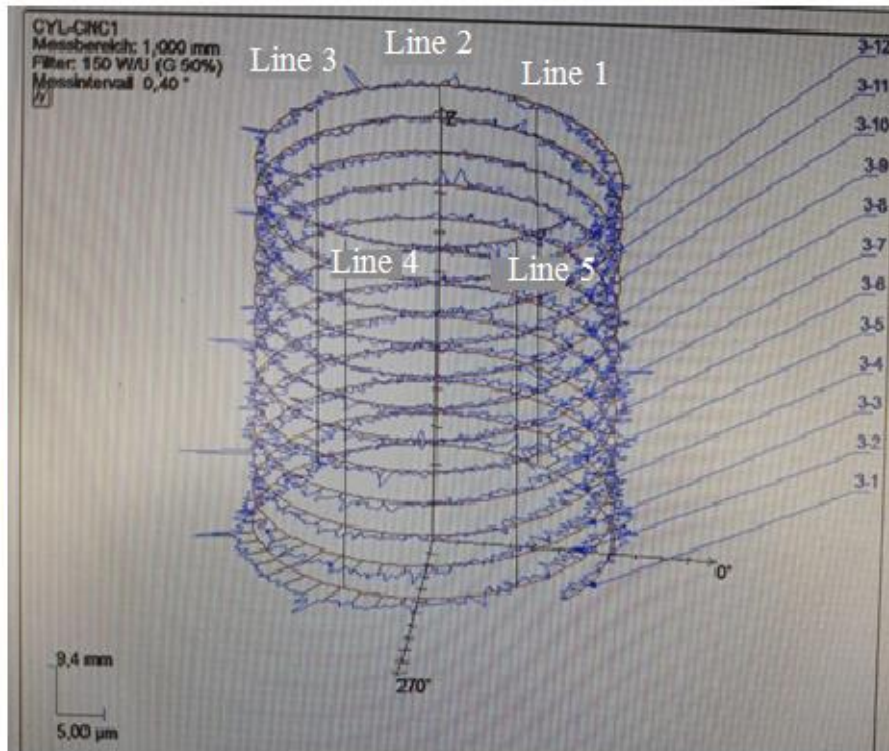
Fig. 3. The position of sections for roundness and straightness measurements

Table 2 shows the values of the mean, standard deviation (S_D), and combined standard uncertainty (S_D) of roundness measurements for the cylinder liner of Messier Ferguson 285 tractor in the five studied sections (Fig. 3). Due to the relative importance of roundness values and straightness outside of the interval, uncertainty by method B (the method obtained from data and information as a result

Given the values of the roundness measurements on the internal surface of the cylinder liner in different transverse positions, the concentricity values of 60.6, 52.5, 45.4, and 28.5 μm were obtained between circles 12 and 1, 12 and 3, 12 and 6, and 12 and 9 around the vertical axis demonstrated in Fig. 3, respectively. These results justify the values of the deviation from the nominal dimension resulting from the severe wear mechanisms in the cylinder liner, which are observed during service and maintenance.

Fig. 5 shows a report of five lengthwise profiles in the positions of 12 sections studied along the internal surface of the cylinder liner. The maximum straightness value (S_a) obtained from measurements along each longitudinal profile indicates the deviation extent of the domain around the guideline of the cylinder liner (vertical axis in Fig. 3) derived from the appropriate LSQ technique.

The maximum wear rate was always obtained at the contact surface of the first piston rings at the high dead point with mean values of 80.2, 60.6, 32.5, 18.2, and 44.4 μm for the longitudinal profiles related to the lines 1, 4, 5, 3, and 2, respectively (Fig. 3). These cases can be justified by adverse and undesirable tribological conditions at the TDC position. As stated, the maximum straightness deviation (80.2 μm) in the longitudinal profile 1 during the impact period is formed as a quick direct reaction force to the lateral force response at high combustion temperatures. These results and findings are in coinciding with the studies conducted by [El-Sherbiny, \(1982\)](#); [Schneider *et al.*, \(1993\)](#); [Kilic, Aguirre-Cruz, & Raman \(2007\)](#); [Nabnu, Ren, Yasuda, Zhu, & Wang \(2008\)](#); [Kumar, Prasad Rao, & Hari Narayana Rao, \(2015\)](#).
