Evaluation of the Plateau Honing on the Friction and Wear Cylinder Liners in Agricultural Tractors

Khodabakhshian, R., and S. Sajadi. 2022. Evaluation of the Plateau Honing on the Friction and Wear Cylinder Liners in Agricultural Tractors. *Journal of Agricultural Machinery* 12 (1): 55-66.

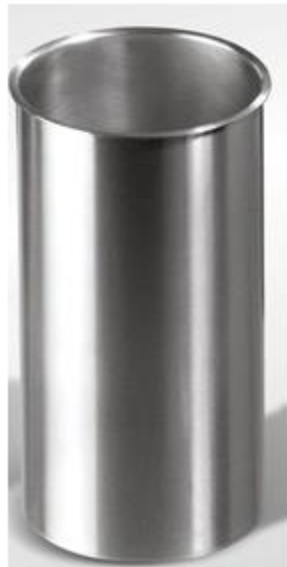
Fig.1. A sample of the cylinder liner

The measured cylinder liner material involves high-quality cast iron (GG 25) which has a 101 mm bore diameter and 233 length. The chemical compositions of the grey cast iron are shown in Table 1. The inner surface of cylinder liners has a hardness of 225-272 HB. The metallography (ASTM A247) results indicated that the liner consists of cast iron along with the pearlite matrix and an insignificant amount of the steadite (iron phosphide eutectic network). Further, the form of graphite is type I, graphite distribution is pattern A, E, and graphite size is 4.5.

Keyhan Sanat Ghaem Company, as one of the largest manufacturers of cylinder liners in Iran and the Middle East, was selected as the case study. The current study was conducted in 2017 in this company. Given the aim of the present study regarding evaluating the cylinder liner of the agricultural tractor, the cylinder liner of the Perkins 4-248 engine was selected, which was associated with the Massey Ferguson 285 tractor. Fig. 1 depicts a sample of this cylinder liner.

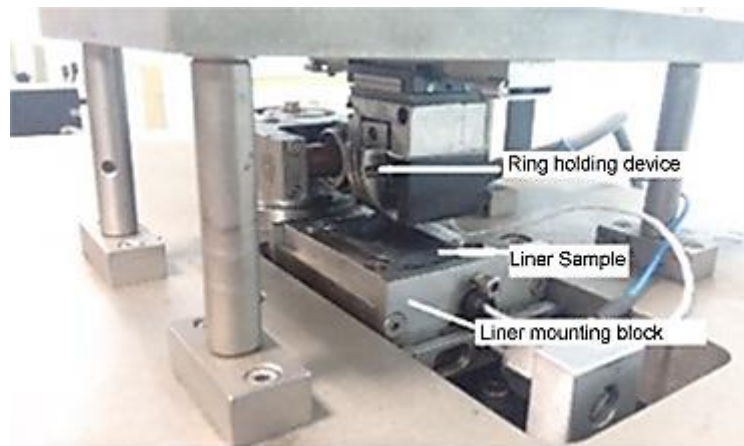
Fig.4. Reciprocating ring-liner tribometer

A reciprocating ring-liner tribometer driven by a slider-crank mechanism with a stroke length of 80 mm (Fig. 4) was implemented for

evaluating the friction and wear characteristics of cylinder liner surfaces with different honing marks against piston ring surfaces with 27 ± 2 °C temperature. Then, the contact surface was lubricated by using a 10W40 semi-synthetic oil (μ_D equal to 0.08 Pas at 40 °C). It should be noted that the total wear test took 120 min in which extra amounts of lubricant were summed (2-3 mL) every 20 min. In addition, the normal force and engine velocity used for these tests were 100 N and 120 rpm, respectively (Yousfi *et al.*, 2015; Kim *et al.*, 2018b).

Friction tests undertake a load level of 100 N and reciprocating velocity of 120 rpm (Yousfi *et al.*, 2015; Kim *et al.*, 2018b). The contact pressure is high and can reach up to 50 MPa thanks to a small contact surface between the liner and ring surface (nearly 2-3 mm^2). Then, the friction was measured after 0, 15, 30, 60, and 120 min. Finally, the friction coefficient was calculated by applying the ratio between the average normal force (F_N) over the mean tangential force (F_T) assessed by strain gauges. The Rtec Multi-Function Tribometer software was used. A balanced Wheatstone bridge has been constructed by mounting four strain gauges over F_T . Two strain gauges have been mounted over the outer surface (for F_N), while rests are placed at the inner surface.

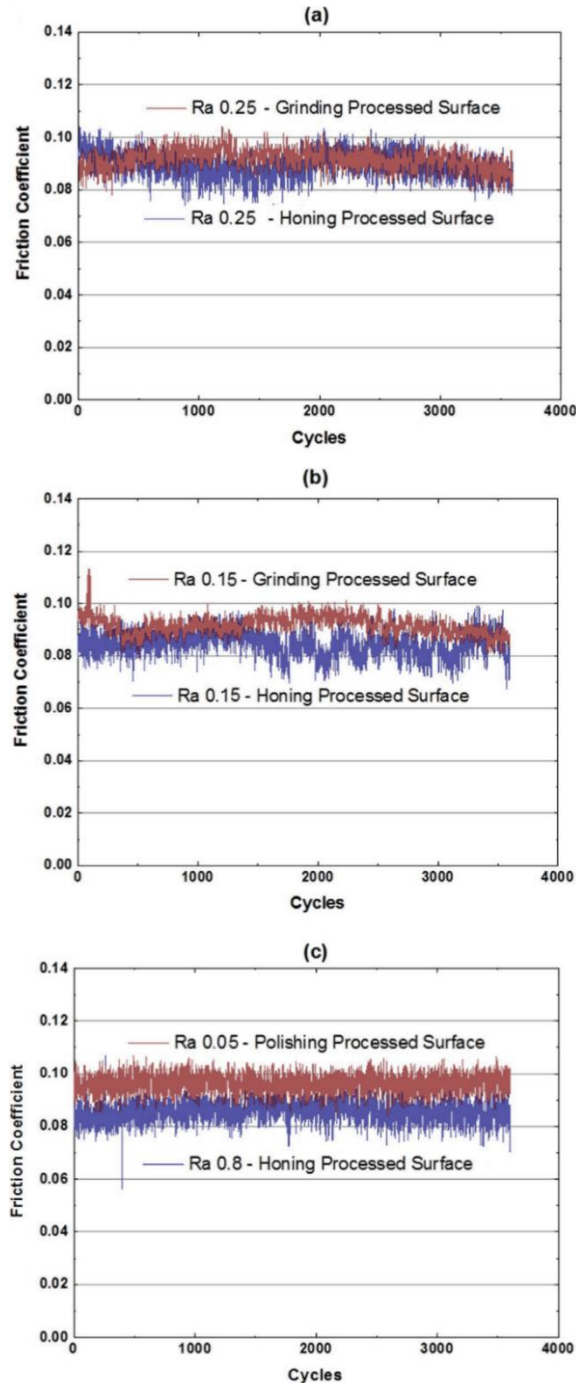
Fig.5. The friction coefficient related to surface roughness: (a) R_a 0.25 μm , (b) R_a 0.15 μm , and (c) R_a 0.8 and 0.05 μm

Fig. 5 illustrates the specimen friction coefficient made by utilizing different surface processes. As displayed, compared to the surfaces with a grinding process with similar surface roughness, honing processed surfaces involve the coefficients with lower friction. Based on the results, no difference was observed in the friction performance related to the surface roughness of 0.8 μm in R_a in comparison to those of smoother surfaces.

However, the highest friction coefficient was reported for polishing processed surfaces which confirmed some numerical results in the mixed lubrication regime (Mezghani *et al.*, 2013; Yousfi *et al.*, 2014). However, these findings should be approved by firing engine experiments that consider real engine conditions. These findings corroborate with those of Yousfi *et al.* (2015), Kim *et al.* (2018b), Anderberg *et al.* (2018), and Grabon *et al.* (2018).

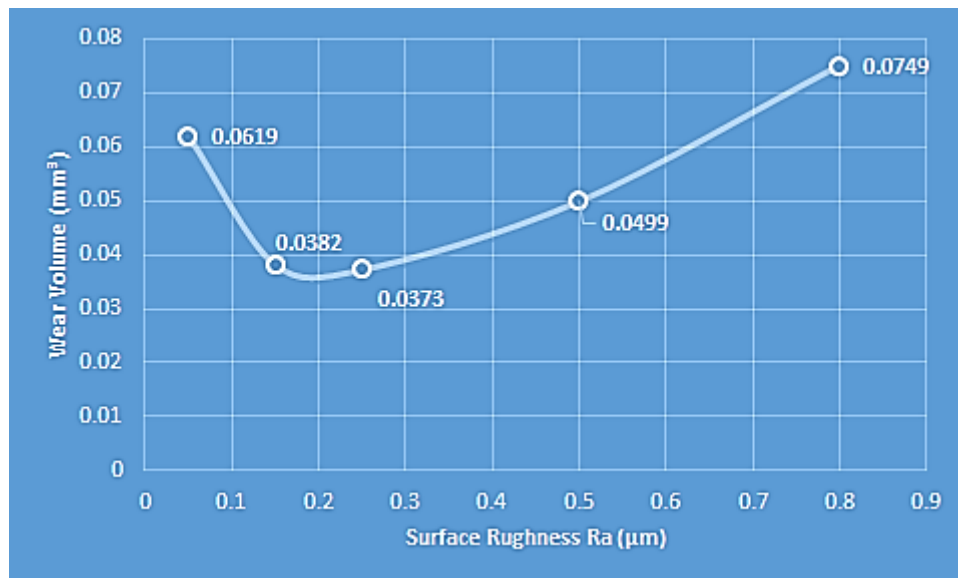
Fig.6. Wear volume of the cylinder liner

there is a negligible amount of wear. Fig. 6 illustrates the wear volumes related to cylinder liners with different roughness of the surface. The least volume of wear is created by the surfaces with the honing marks of 0.1-0.2 μm in R_a .

However, the highest wear volume was observed in the surface roughness of $0.8 \mu\text{m}$ in R_a . Based on the results, the volumes of wear increased by enhancing the surface roughness from $0.2 \mu\text{m}$ since colliding jagged asperities resulted in increasing in polishing effects. Contrarily, a decrease in the surface roughness from $0.1 \mu\text{m}$ led to an increase in the volumes of the wear by considering the fact that an increase in the real contact area between steel ball and cylinder liner results in creating more severe wear by adhesion. Other studies such as Yousfi *et al.* (2015) and Kim *et al.* (2018b) reported a similar trend for the wear volumes

volumes of wear (Fig. 6). Thus, there is an optimum range of surface roughness to reduce
